Your Inspection Report

11 Lyle St
Des Plaines, IL

INSPECTION DATE:
Wednesday, October 31, 2007

Report No. 2818, v.2

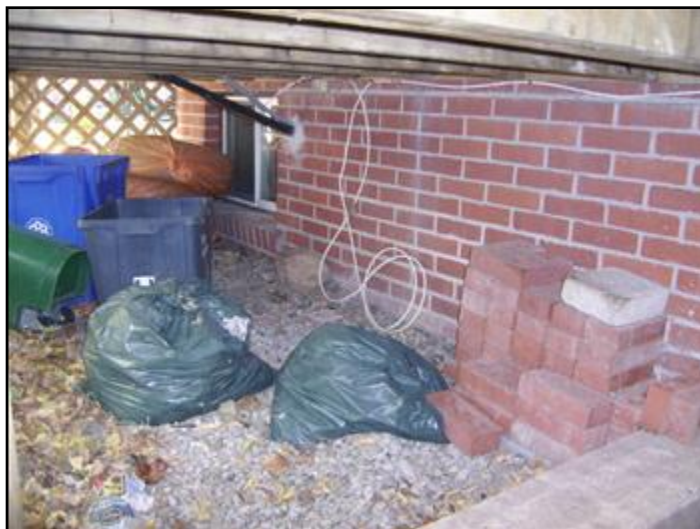
1. East

Condition: • [Improper slope](#)

Implication(s): Chance of water damage to contents, finishes and/or structure

Location: South, East

Task: Improve/Repair

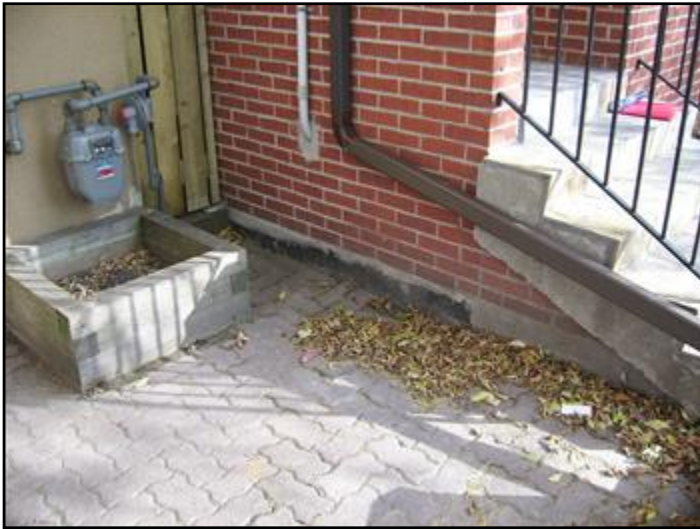
2. Northwest

Condition: • [Improper slope or drainage](#)

Implication(s): Chance of water damage to contents, finishes and/or structure

Note: Improper grading on walkway, patio and driveway

Task: Improve/Repair

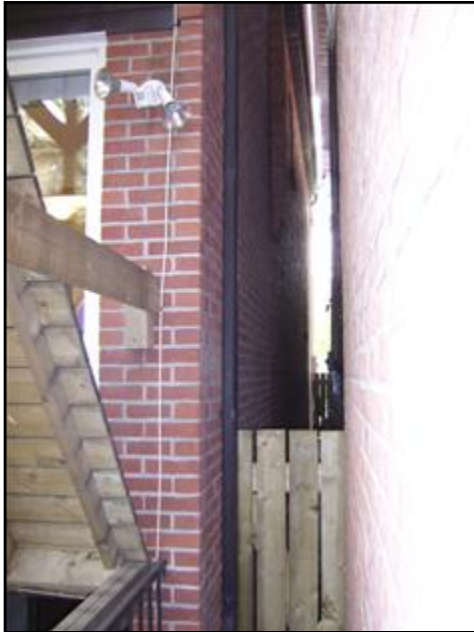
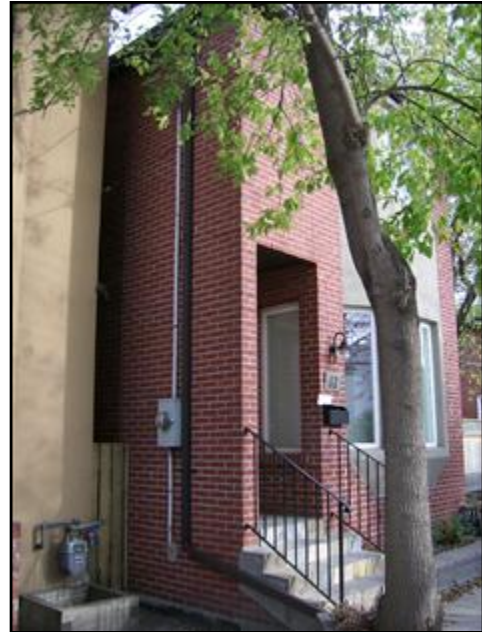
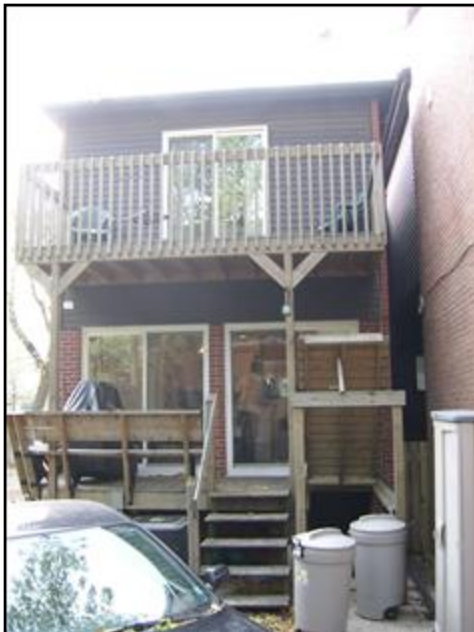
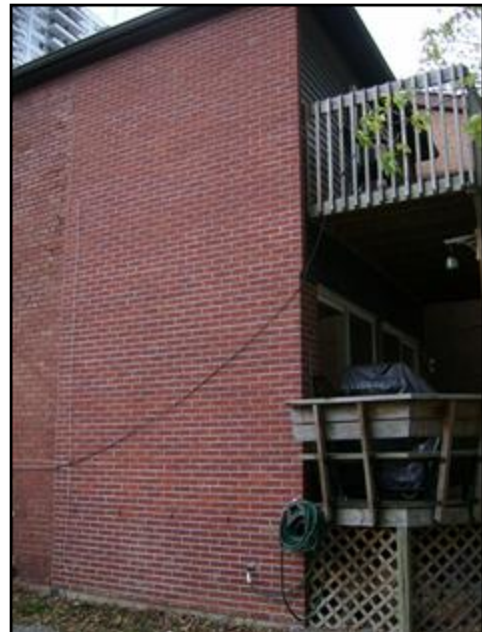
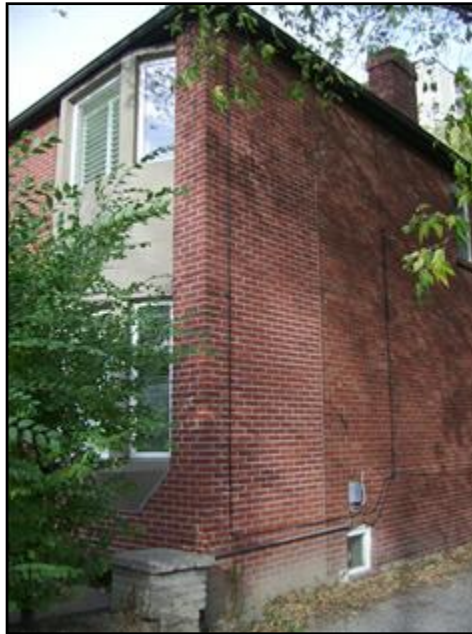
Condition: • Masonry veneer walls appear sound overall.

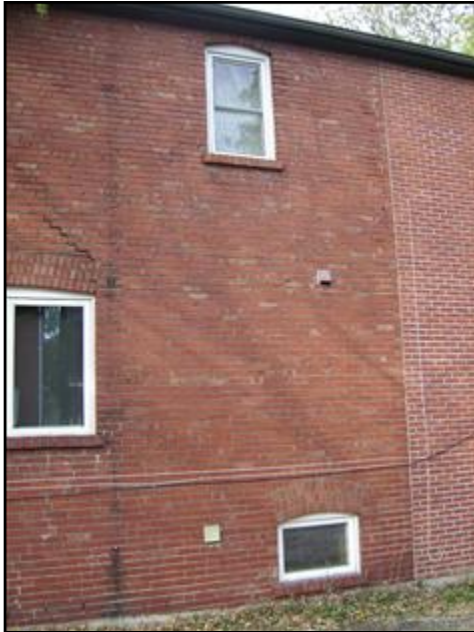
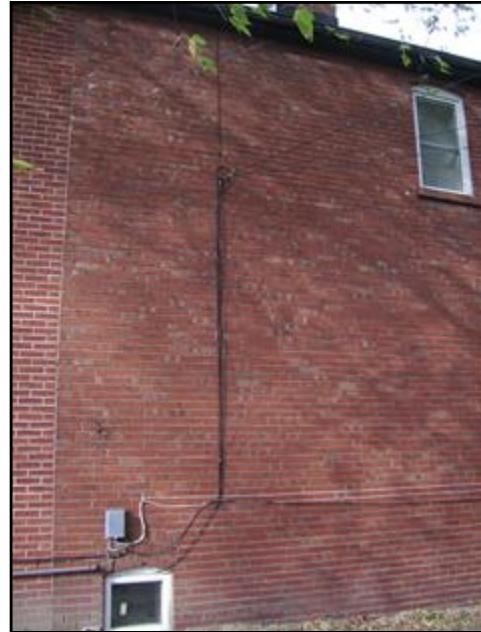
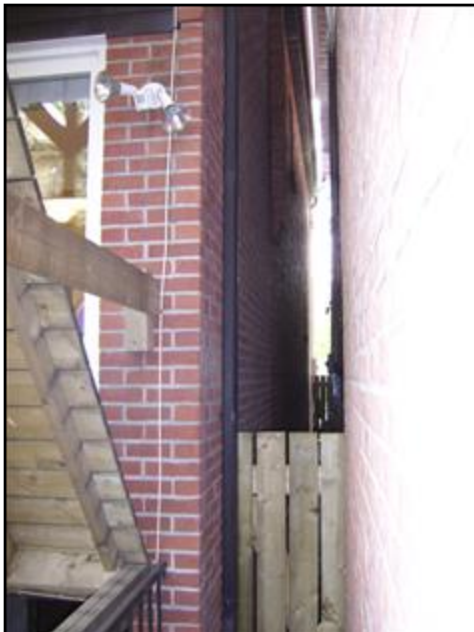
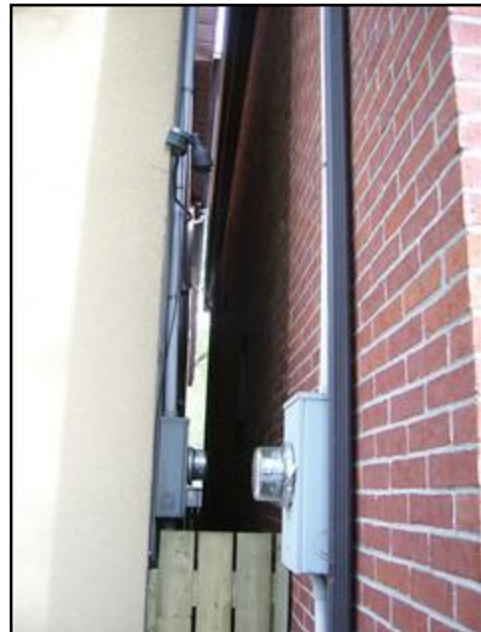
Condition: • Solid masonry walls appear sound overall.

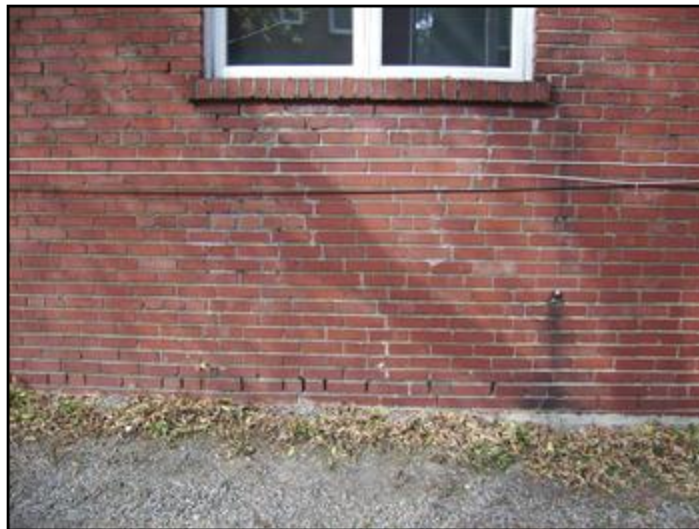
14. South wall

Condition: • [Mortar deteriorating](#)

Implication(s): Weakened structure | Chance of structural movement

Note: At grade level.

Task: Improve/Repair

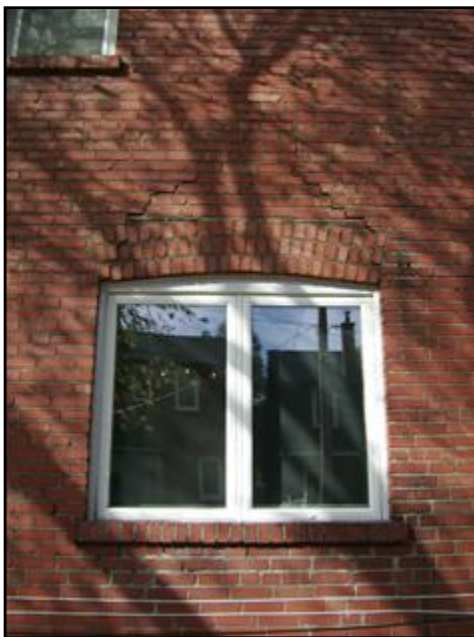
15. South wall - First floor arch

Condition: • [Cracked](#)

Implication(s): Weakened structure | Chance of structural movement

Note: Loose bricks, poor end bearing.

Task: Repair

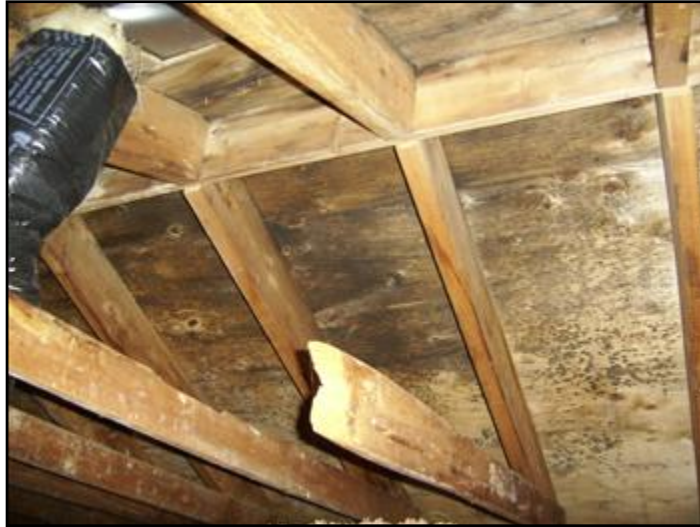
17.

Condition: • [Mold](#)

Implication(s): Weakened structure | Chance of structural movement

Note: Mold likely a result of high humidity due to bathroom exhaust fans discharging into the attic and inadequate attic ventilation . See INTERIOR: EXHAUST FANS | Exhaust duct and INSULATION: ATTIC/ROOF | Roof vents also.

Task: Further evaluation/Repair

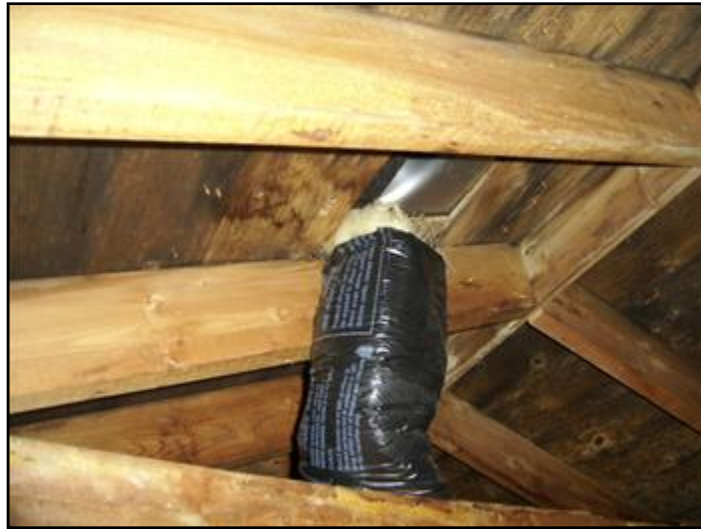
18.

Condition: • [Not vented to exterior](#)

Implication(s): Chance of condensation damage to finishes and/or structure

Task: Repair
