Your Inspection Report

11 Lyle St
Des Plaines, IL

INSPECTION DATE:
Wednesday, October 31, 2007

Report No. 2818, v.2

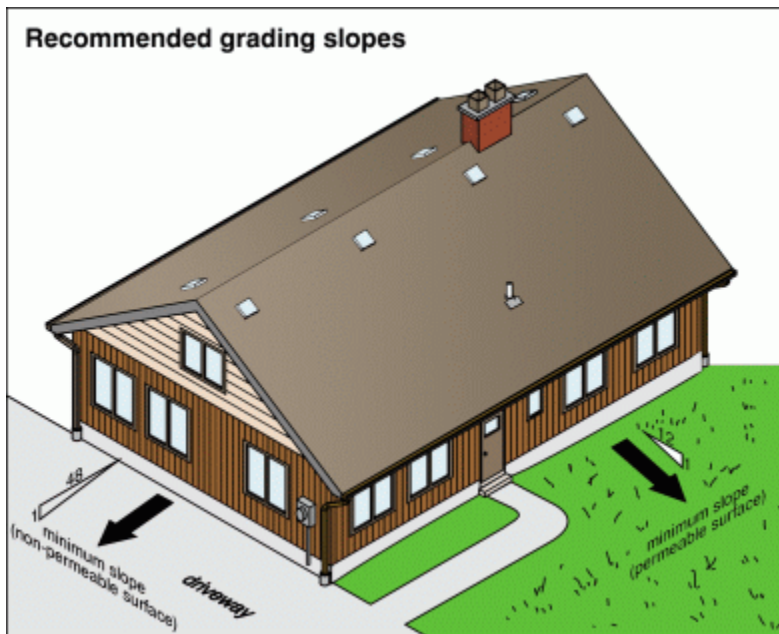
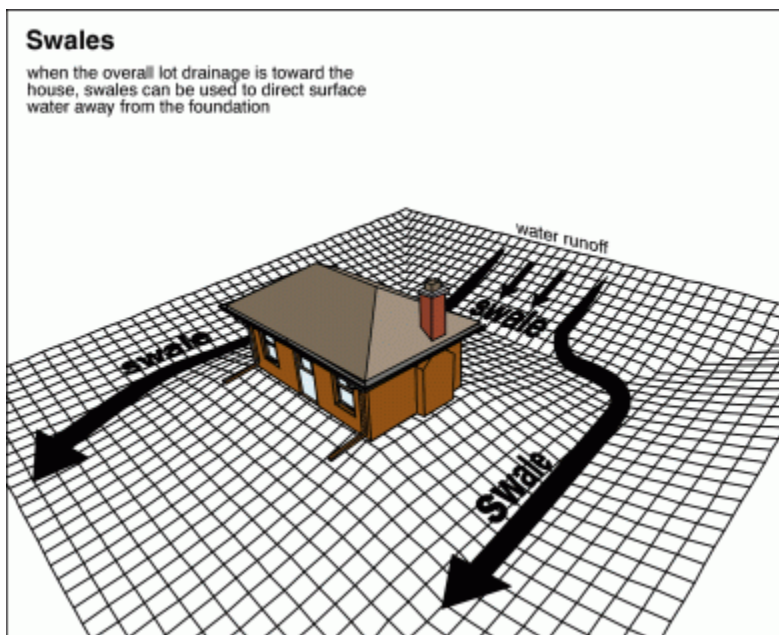
Condition: • [Improper slope](#)

Implication(s): Chance of water damage to contents, finishes and/or structure

Location: South, East

Task: Improve/Repair

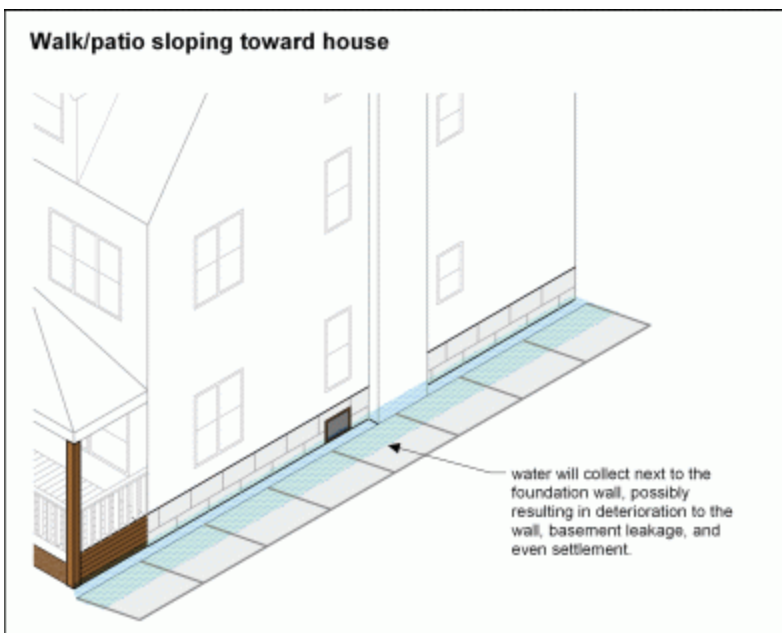
Condition: • [Improper slope or drainage](#)

Implication(s): Chance of water damage to contents, finishes and/or structure

Location: North, West, South

Note: Improper grading on walkway, patio and driveway

Task: Improve/Repair

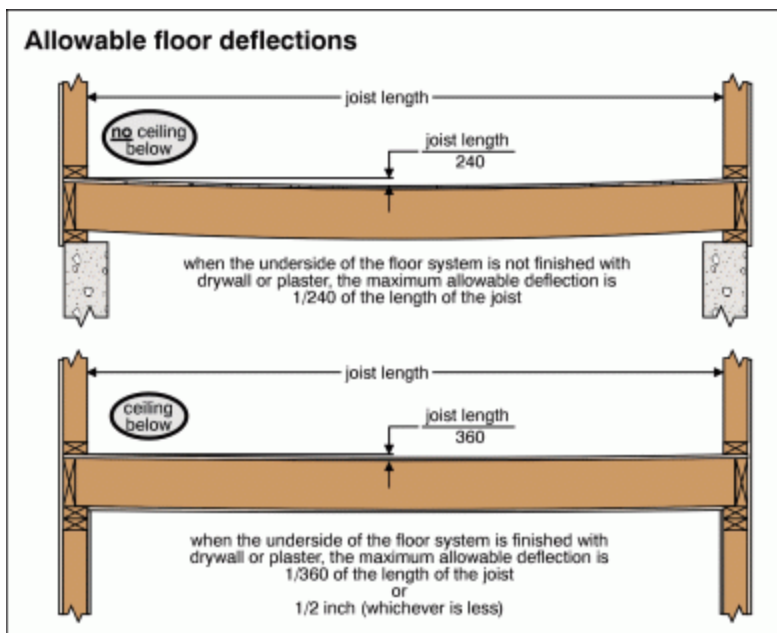
Condition: • [Sag or springy](#)

Task: Monitor

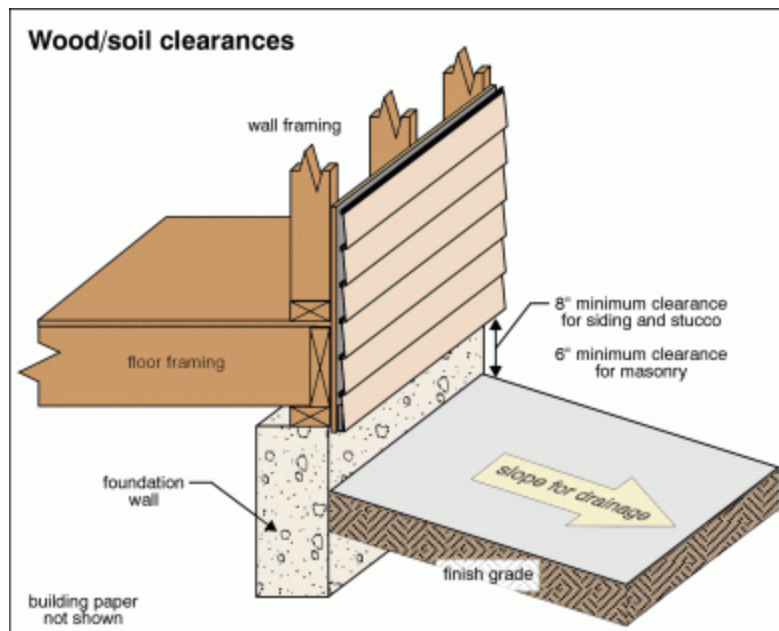
Condition: • [Masonry or wood too close to grade](#)

Implication(s): Chance of damage to structure

Task: Improve/Repair

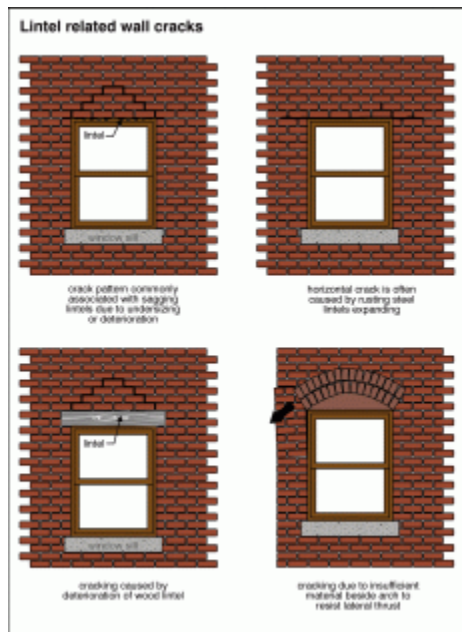
Condition: • [Cracked](#)

Note: Loose bricks, poor end bearing.

Task: Repair

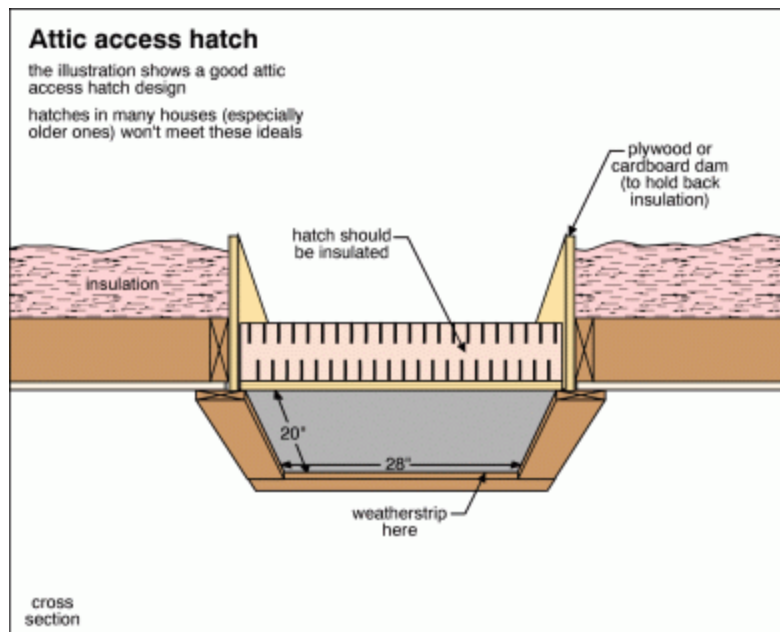
Condition: • [Not insulated and not weatherstripped](#)

Implication(s): Chance of condensation damage to finishes and/or structure | Increased heating and cooling costs | Reduced comfort
